# Project Report

# Slope Stabilisation

## Vale Primary School

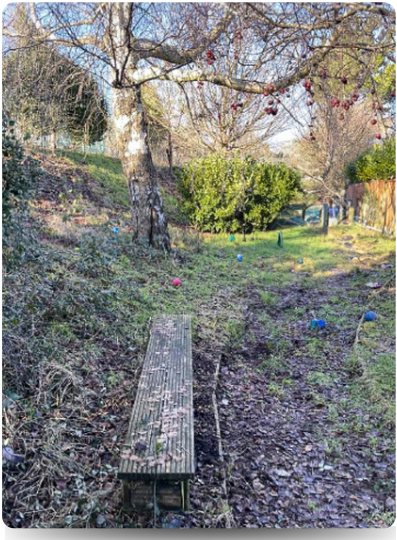
Prior to installation, a comprehensive site test was undertaken to demonstrate the suitability of the Vulcan Earth Anchor system for the site's specific ground conditions. Two AS-30 Vulcan Earth Anchors were installed and successfully tested to their maximum capacity of 60kN, significantly exceeding the project's design load requirements. Based on these results, the specification was revised to AS-20 anchors, which provided more than adequate holding capacity at a lower cost.

The design required all anchors to be proof load tested to 8kN and then locked off at 5kN. Ground conditions included approximately 1m of medium-density topsoil with SPT values of 10-15, overlying chalk with higher strengths of 30-40. Anchors were driven to a depth of 2m, where testing confirmed reliable performance across the site, ensuring confidence in the long-term stability of the solution.
